Manhole Inspection Summary

Manhole # S19W__009MH

Insp Date: **7/1/08 9:29 AM**

Location Address: **2322 james st**

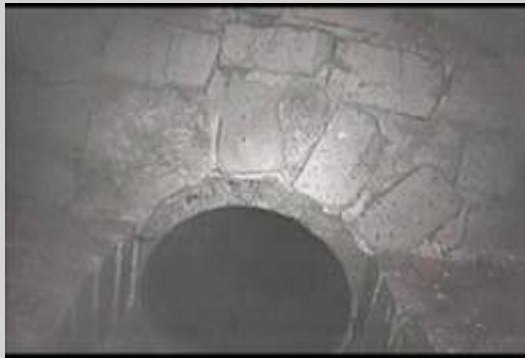
12 O'Clock Outflow

8 in. Circular Gravity Sewer
Pipe Out @ 12 O'Clock

Pipe Height: **8.4** (in.) Rod and Bar (Angled)
Pipe Material: **Clay** ☐ Pipe Lined
Invert Depth: **10.75** (ft.) Flow Characteristics: **Slow**
Deposits: ☒ None ☐ Mud ☐ ~~Gravy~~ ☐ Debris ☐ Grease
Silt Depth: **0** (in.) Deposits Extent:
Infiltration: **None** Pipe Seal Cond: **Sound**

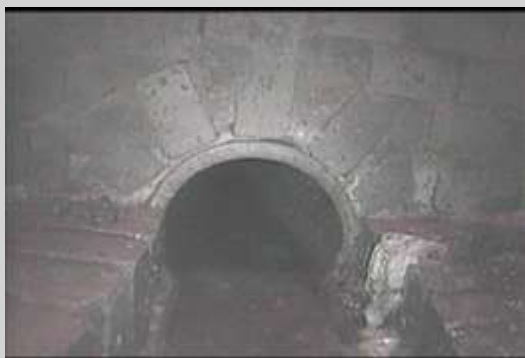
3 O'Clock Inflow

8 in. Circular Gravity Sewer
Pipe In @ 3 O'Clock

Pipe Height: **8.4** (in.) Rod and Bar (Angled)
Pipe Material: **Clay** ☐ Pipe Lined
Invert Depth: **10.62** (ft.) Flow Characteristics: **Slow**
Deposits: ☒ None ☐ Mud ☐ ~~Gravy~~ ☐ Debris ☐ Grease
Silt Depth: **0** (in.) Deposits Extent:
Infiltration: **None** Pipe Seal Cond: **Sound**
